Using an Existing Crown to Repair a Damaged Cast Post and Core Restoration

Arabolu M, Nair KC, Raheel SA, Tarakji B, Azzeghaiby SN, Nassani MZ. Using an existing crown to repair a damaged cast post and core restoration. J Int Oral Health 2014;6(5):111-3.

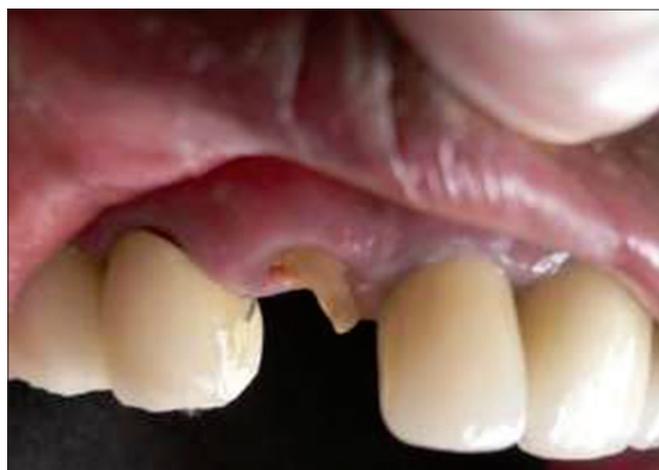
1. A 34-year-old female patient reported with fractured maxillary right canine tooth (Figure 1). On examination, it was found that the tooth was the root canal treated and restored with a cast post and core and a metal ceramic crown over it (Figure 2). The core was fractured leaving the cast post embedded in the root.

Figure 1: Fractured right maxillary canine.

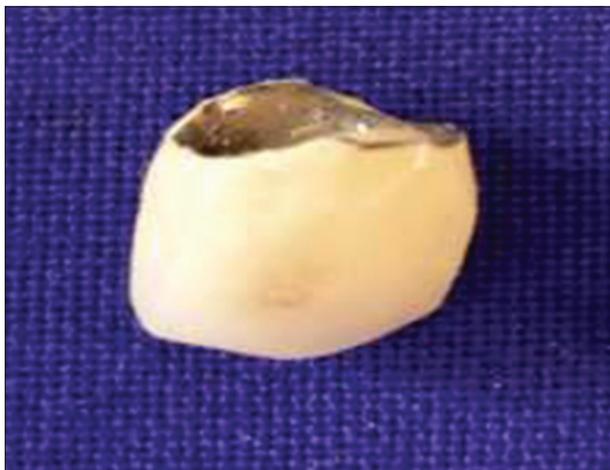
Figure 2: Intact metal ceramic crown.

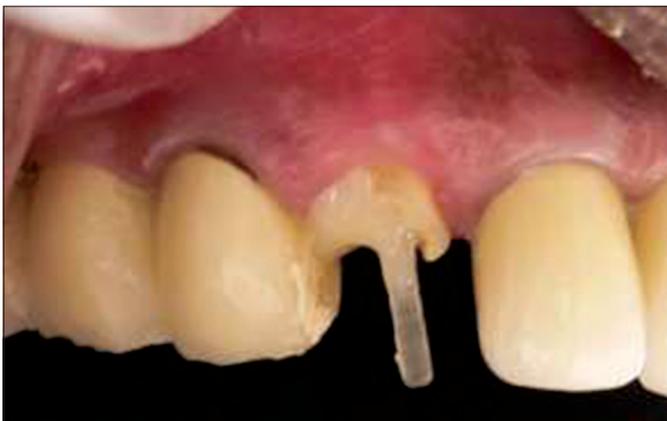
Figure 3: Glass fiber post bonded to tooth.

2. The post was loosened using ultrasonic vibrations and retrieved using an artery forceps. The residual cement in the post space was removed and a fiber post of diameter 1.5 mm (Flexi-Post, ColteneWhaledent) was bonded using dual-cured composite resin (Paracore, ColteneWhaledent) (Figure 3).

the tooth and the supporting bone. Specimens restored with fiber-reinforced post systems offered more homogenous stress distribution than cast posts as fiber posts possess a similar modulus of elasticity to that of dentin.^{6,7} Hence, it was decided to use a glass fiber post for this case. The use of PTFE tape provides a space of approximately 50 μm , which was used to accommodate the cement.⁸

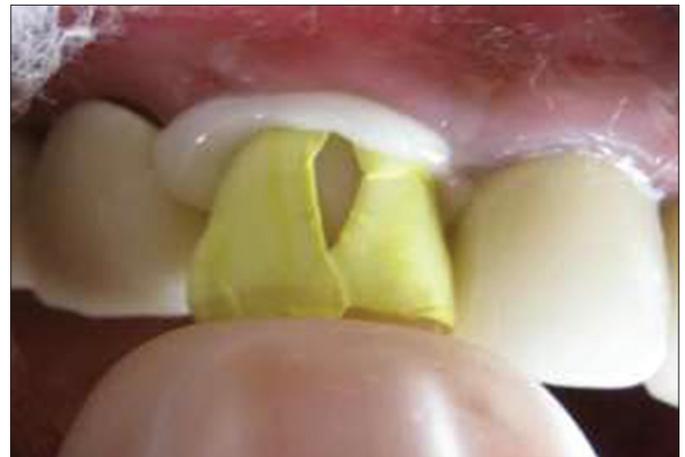
Figure 5: Crown adapted to the tooth with composite resin.

3. The crown was intact, and it was decided to use the same for restoring the fractured tooth. A 50 µm polytetrafluoroethylene (PTFE) (teflon) tape was adapted on the tissue surface of the crown and a dual-cured core build-up composite resin (Paracore, ColteneWhaledent) was injected into the crown and positioned over the bonded post (Figures 4-6). It was then light polymerized for 40 s.

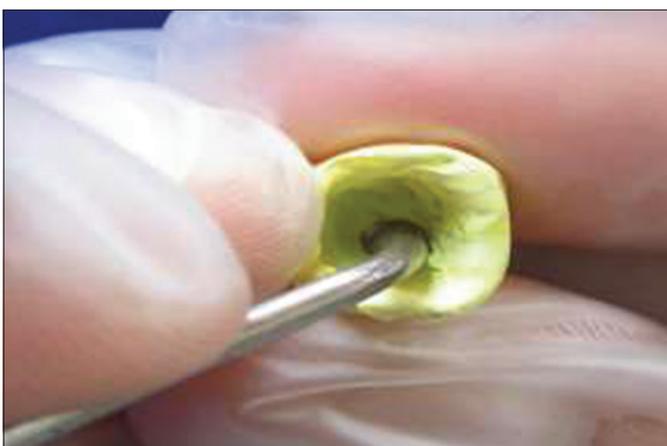
Figure 4: Adaptation of teflon tape to existing crown.

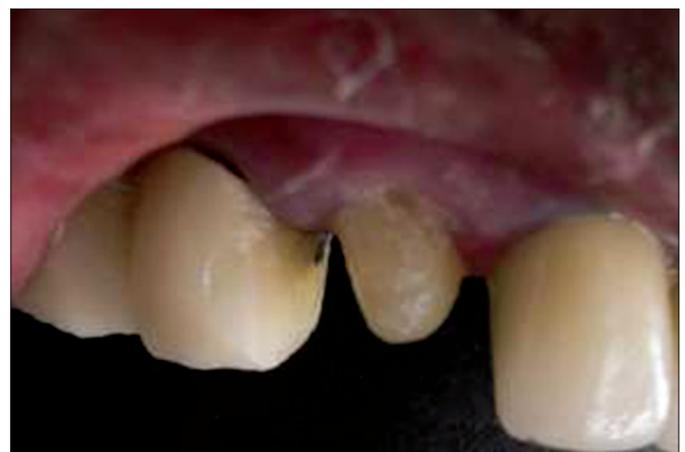
Figure 6: Core build-up with composite resin.

4. The crown was then removed leaving the core bonded to the post and the tooth structure. The core was light

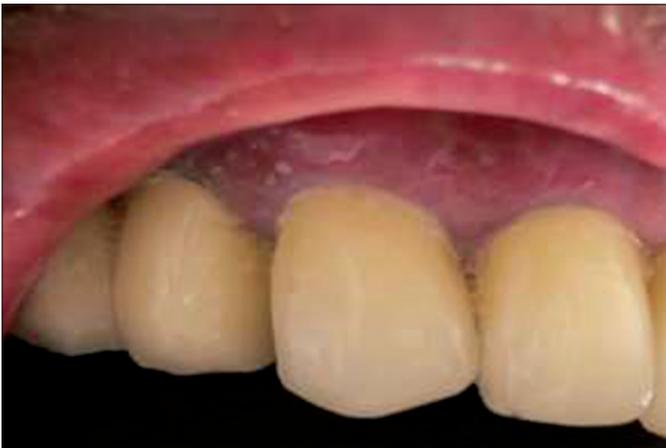
Figure 7: Crown cemented using glass ionomer cement.

polymerized again for 40 s. The teflon tape was removed from the crown, and the crown was cemented to the core using glass ionomer cement (GIC gold label glass ionomer luting and lining cement) (Figure 7). The patient was followed up for 1 year, and it was uneventful.
